Lead white blackening on graphic art

Morten Ryhl-Svendsen^{1,2,*}, Anna Vila¹, David Buti¹, Niels Borring¹, Johanne M. Nielsen¹, Birgit Vinther Hansen³

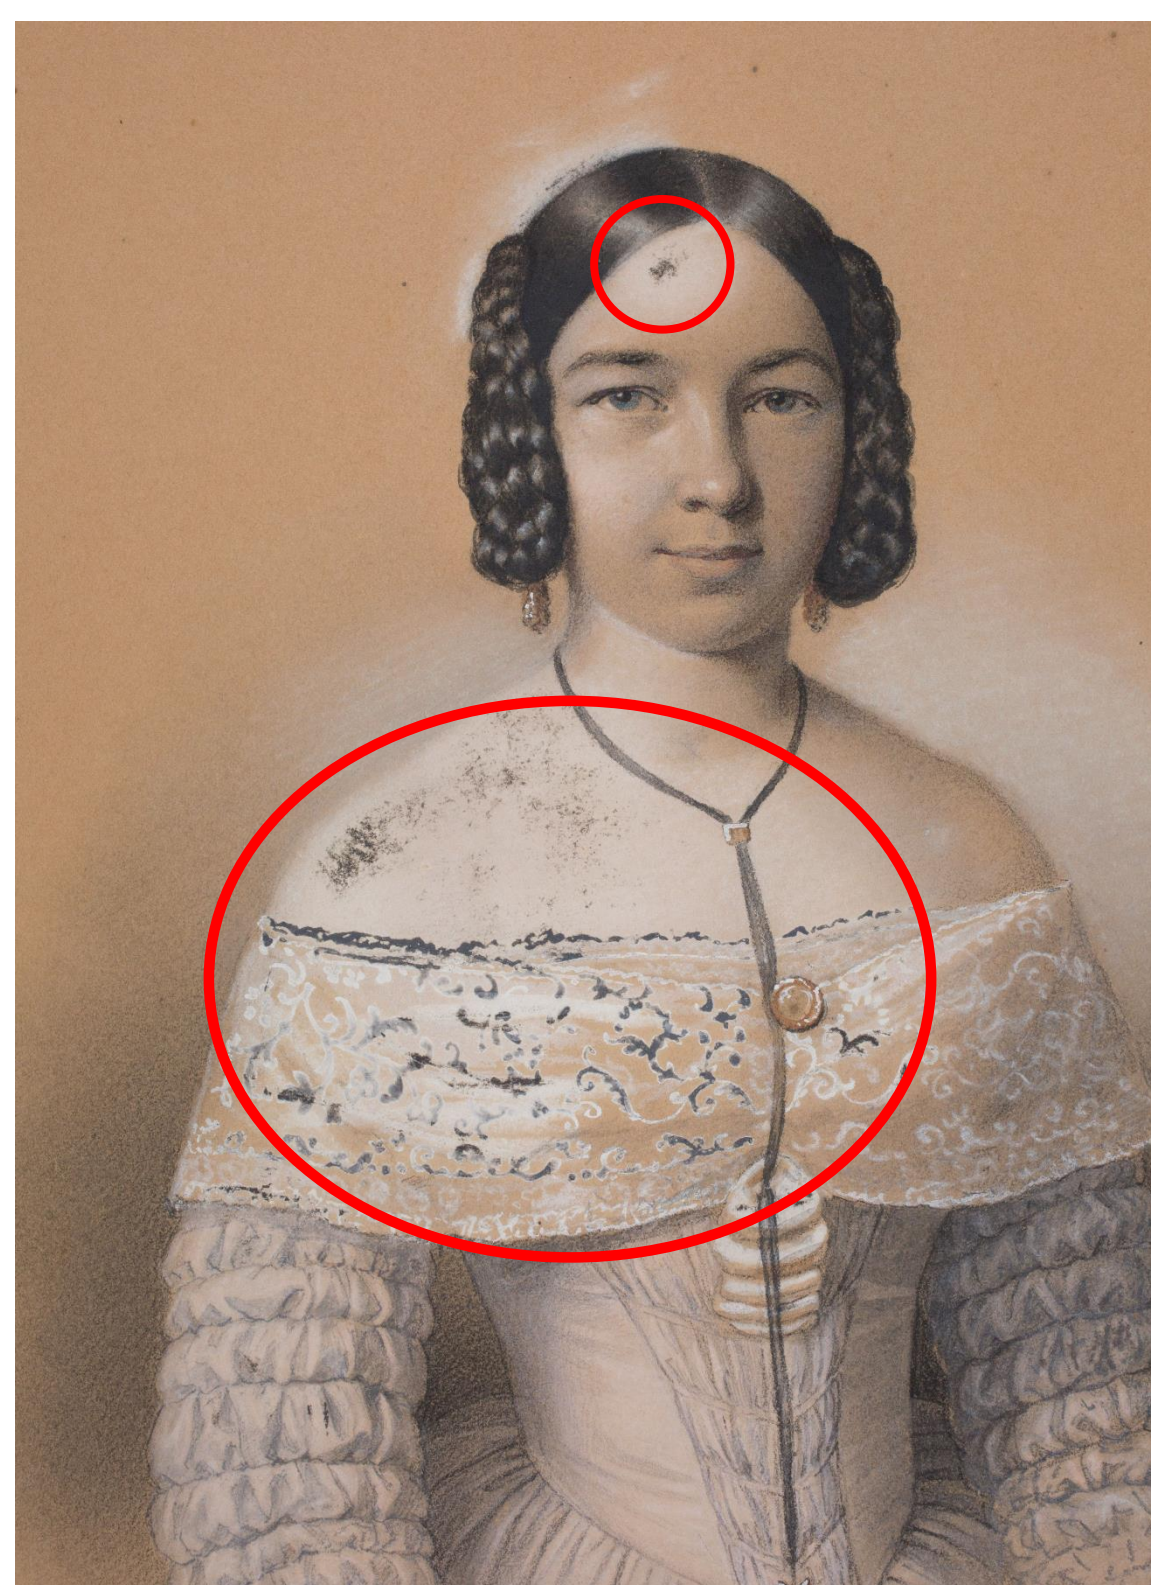
Lithograph with blackened lead white highlights (in red circles).
Collection of The Royal Library, inv.no. 1976-233/2

For modern indoor environments the darkening of lead white (basic lead carbonate) is mainly attributed to the action of hydrogen sulfide (H_2S) present in the atmosphere, resulting in the formation of PbS (black galena).

We attribute the degradation to a combination of poor archival housing materials, infiltration of unfiltered outdoor air, and in some locations the presence of many people.

Chemical filtration may solve the problem on a room scale, while on a microenvironment scale the identification and removal of poor cardboard materials will be necessary.

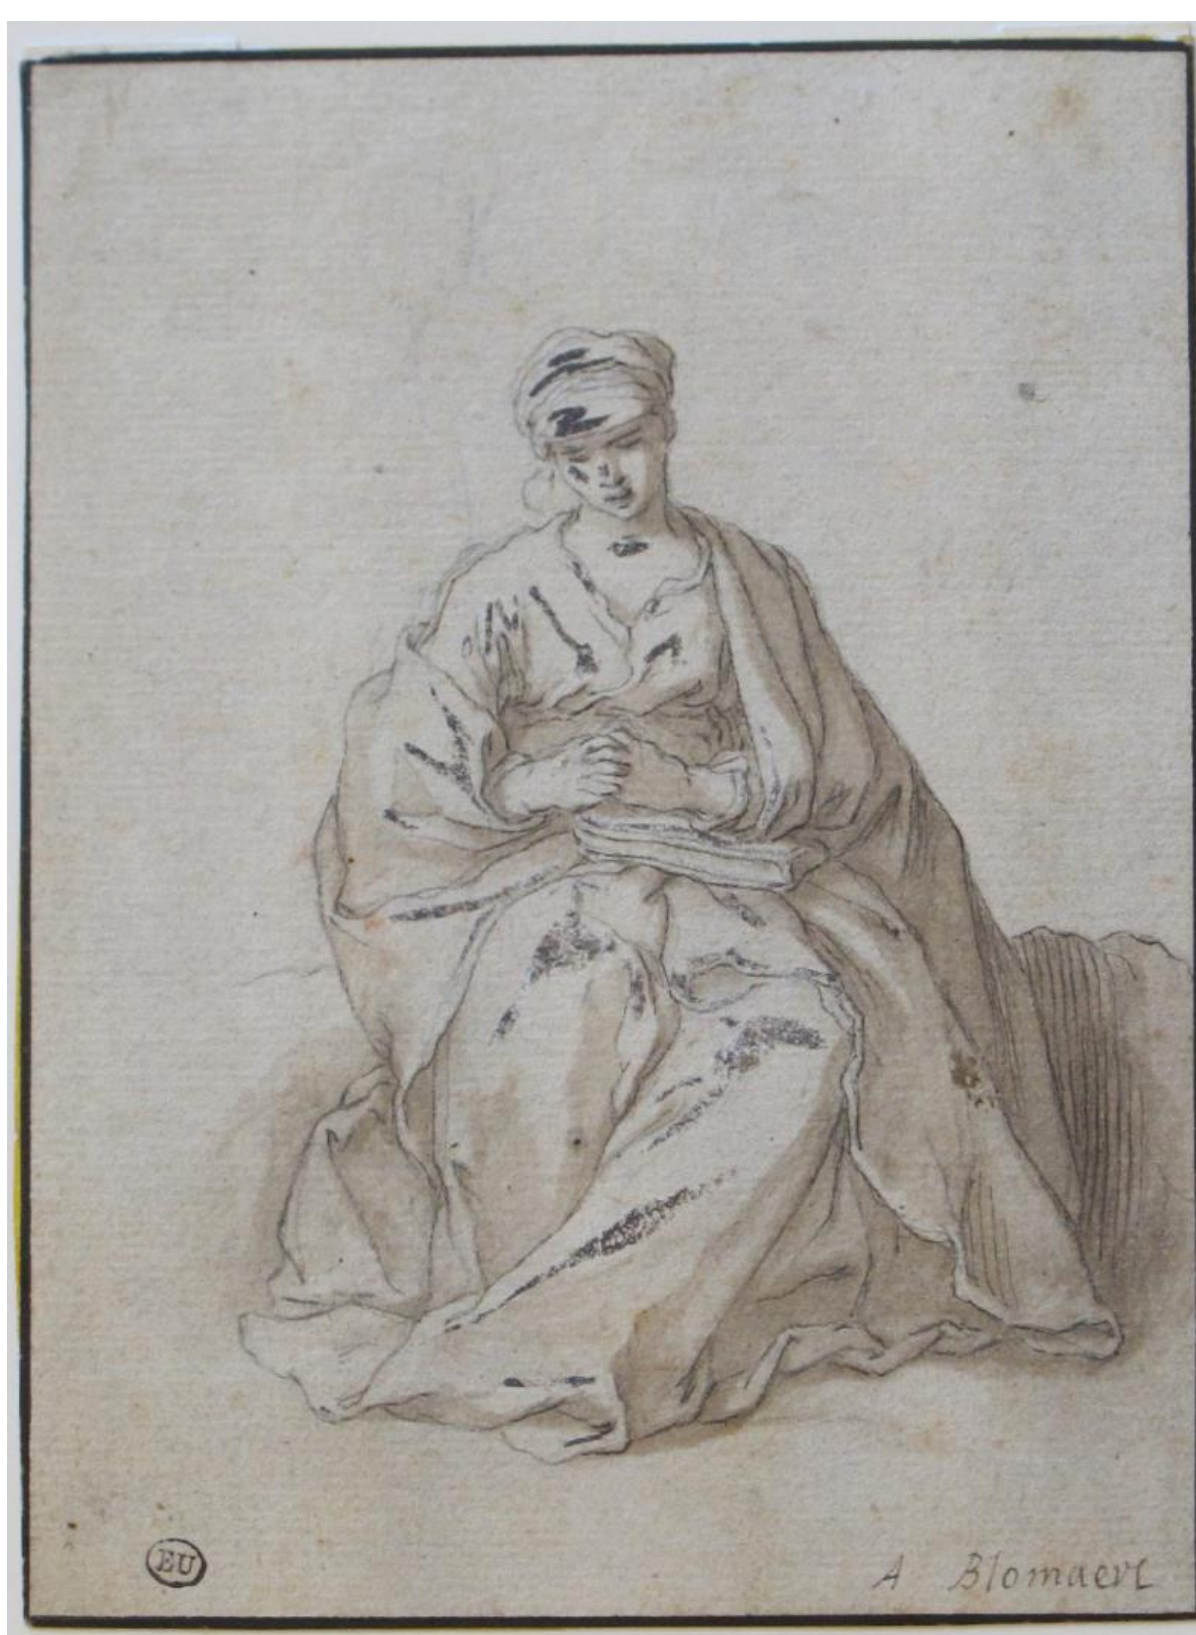
Drawing with blackened lead white highlights. Collection of Statens Museum for Kunst, Attr. to A. Bloemart, inv.no. KKSGb12821

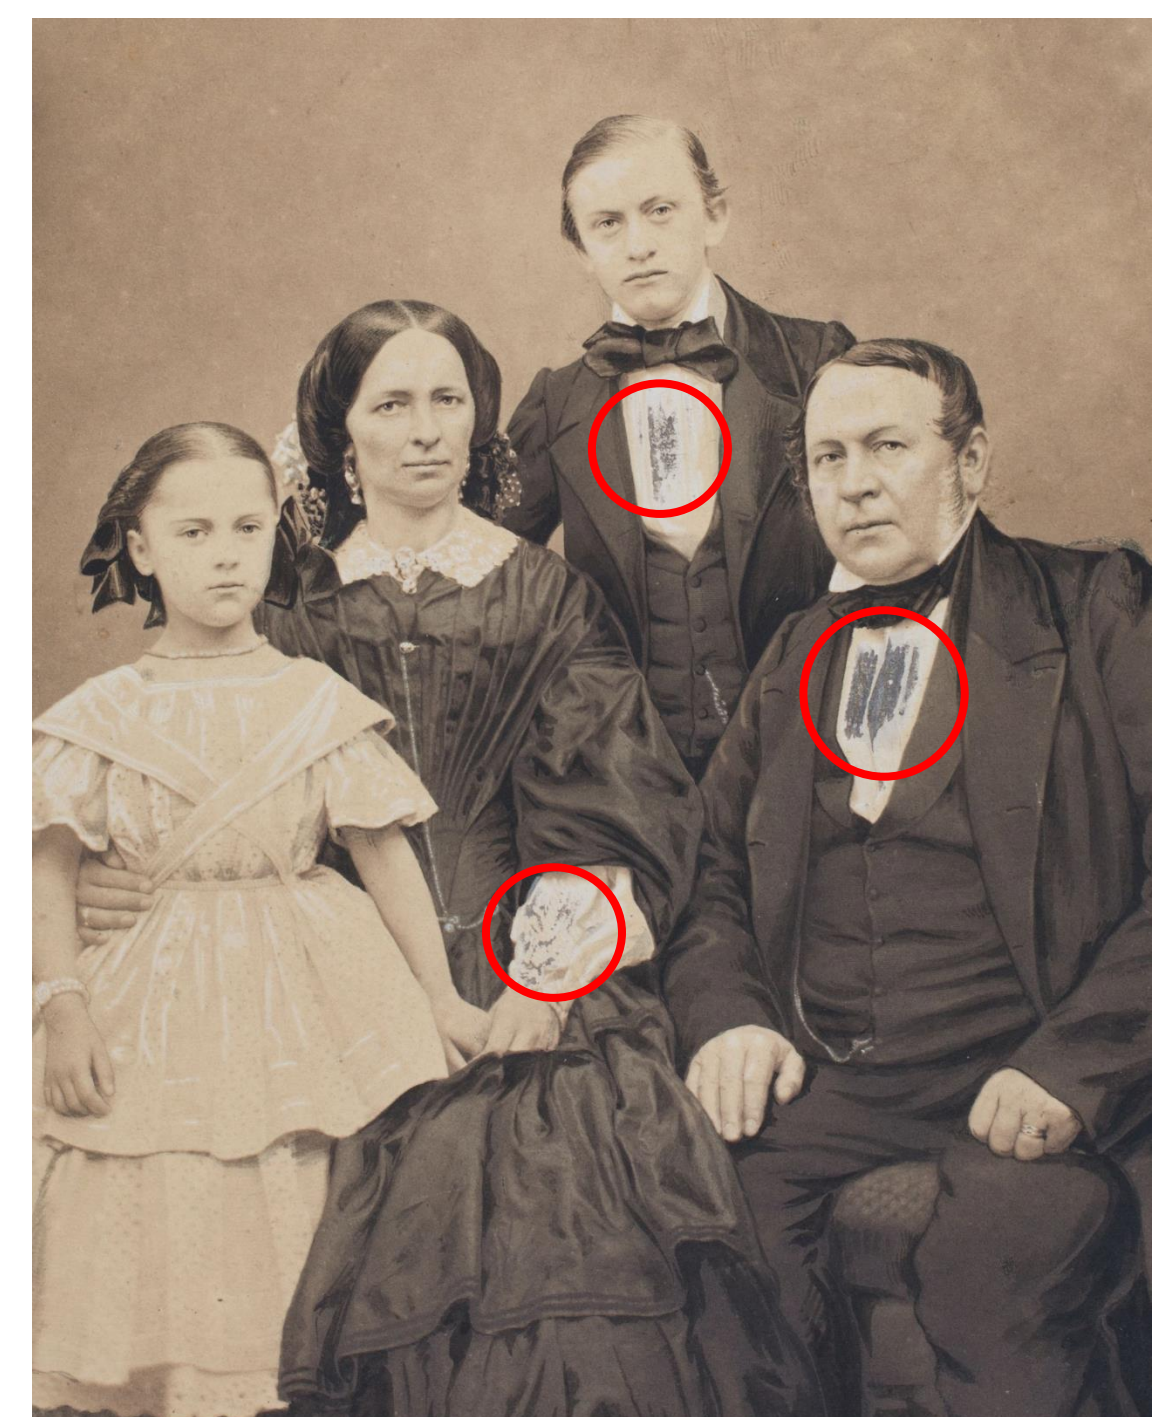
Salted paper print (photograph), with blackened lead white retouch.
Collection of The Royal Library, inv.no. Fot. Hist. Bl. °4, 266.
