9th Indoor Air Quality meeting Chalon-sur-Saone, France

Thenardite-Mirabilite cycles in historical buildings

D. Camuffo¹, C. Bertolin¹, C. Amore², A. Bergonzini² and P. Brimblecombe³

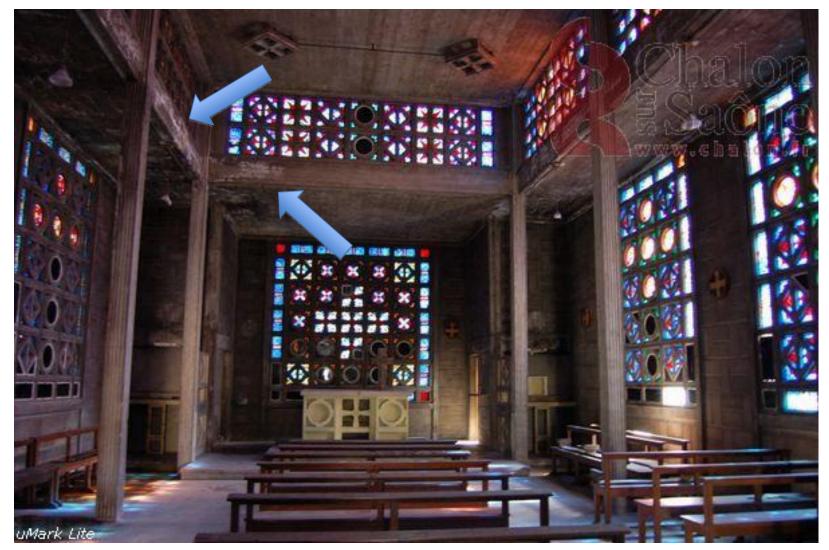
Chappelle de la Colombière – Water percolating inside the concrete envelope, pinpointed by efflorescence. Potential risk of damaged structures for thenardite-mirabilite cycles. Hypothesis to be verified.
