Tudor tapestries environmental protection project:

**when risk mapping and analysis informs
innovative mitigation measures**

Constantina Vlachou - Mogire ,
Ian Gibb,
Kate Frame

IAQ 2016, 3-4 March 2016

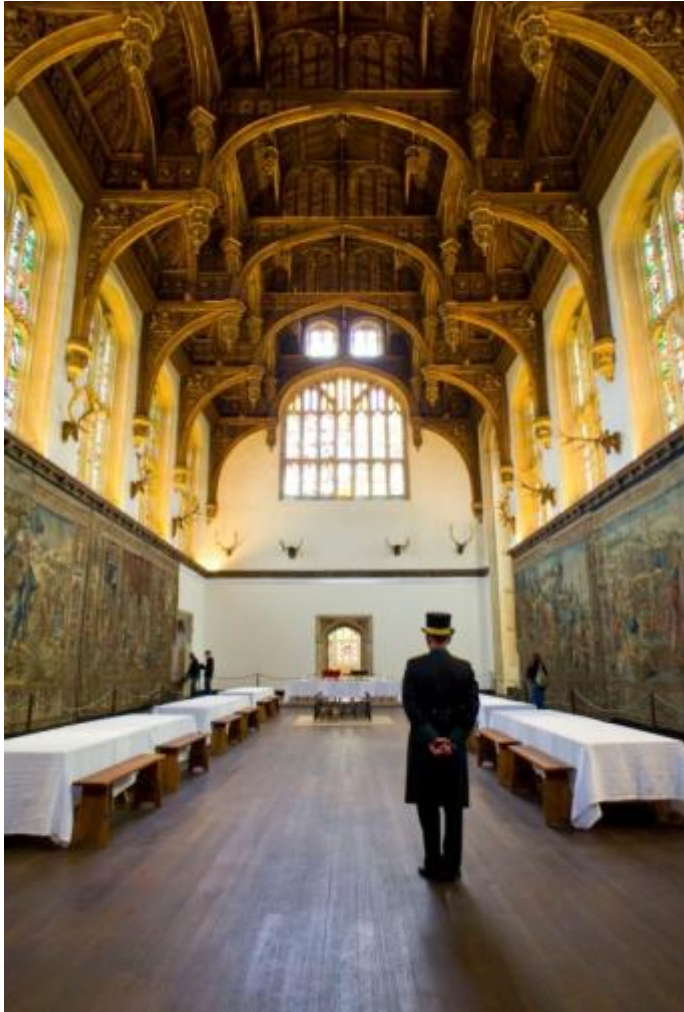
Monitoring locations

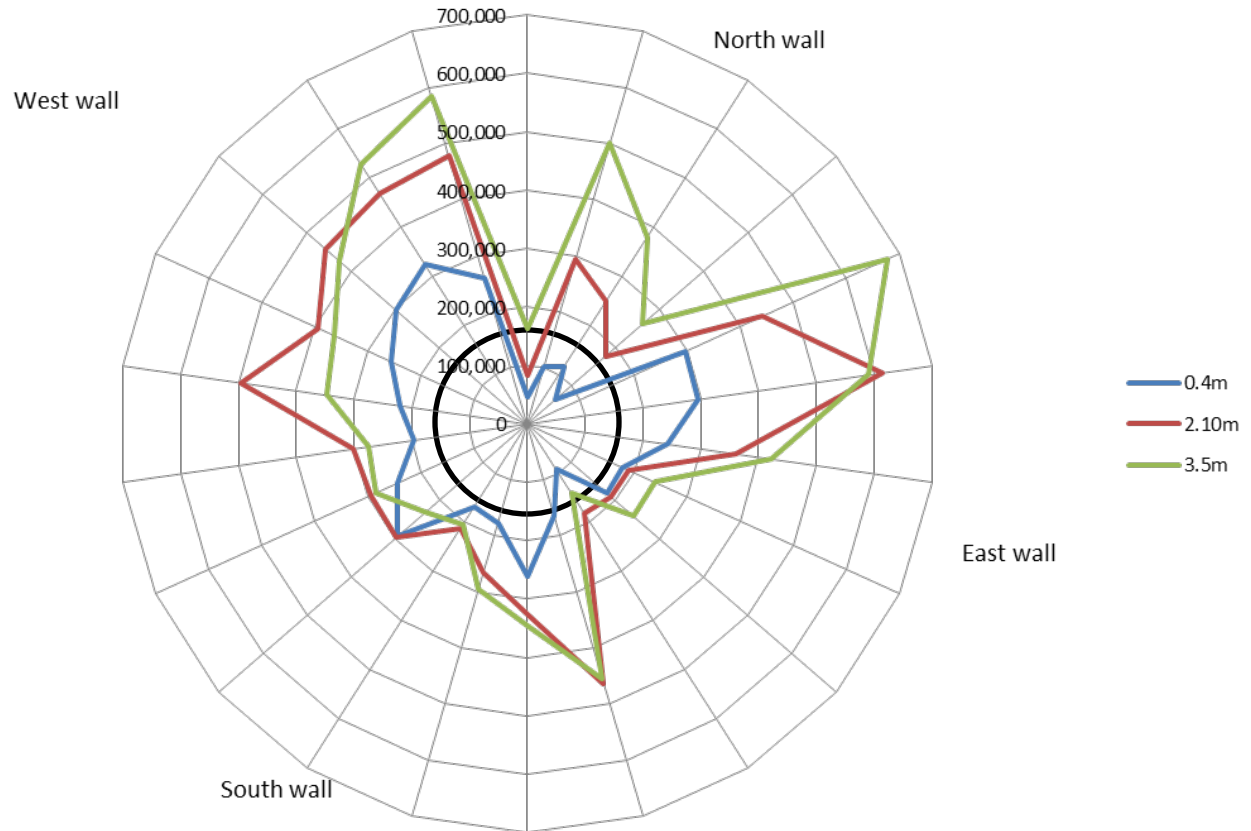
Results - ambient + direct light

150,000 lux.hours

Great Watching Chamber ambient light cumulative lux hours
March 2012 - February 2013

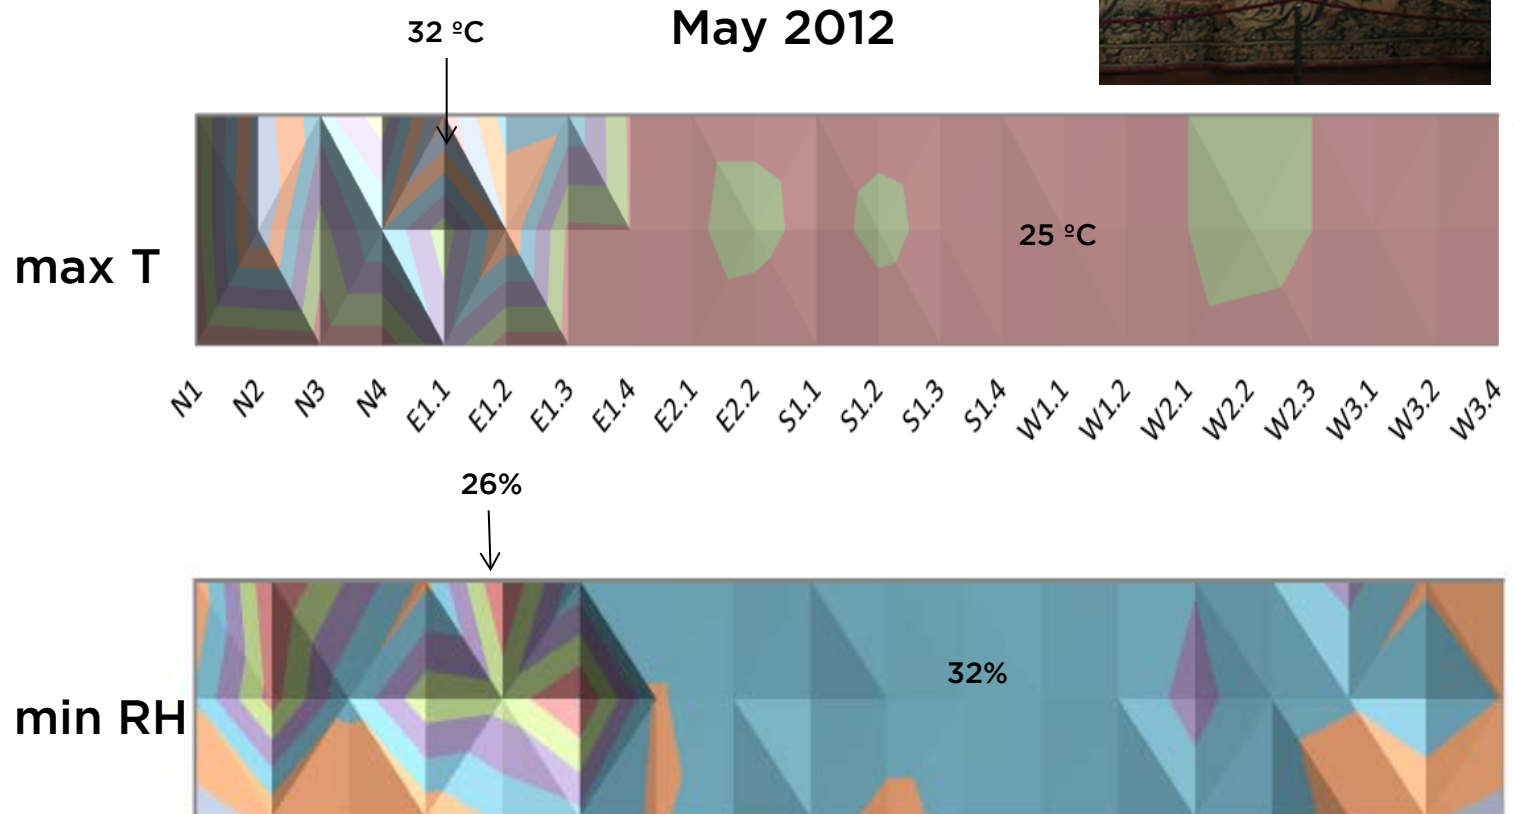
Results -solar gain

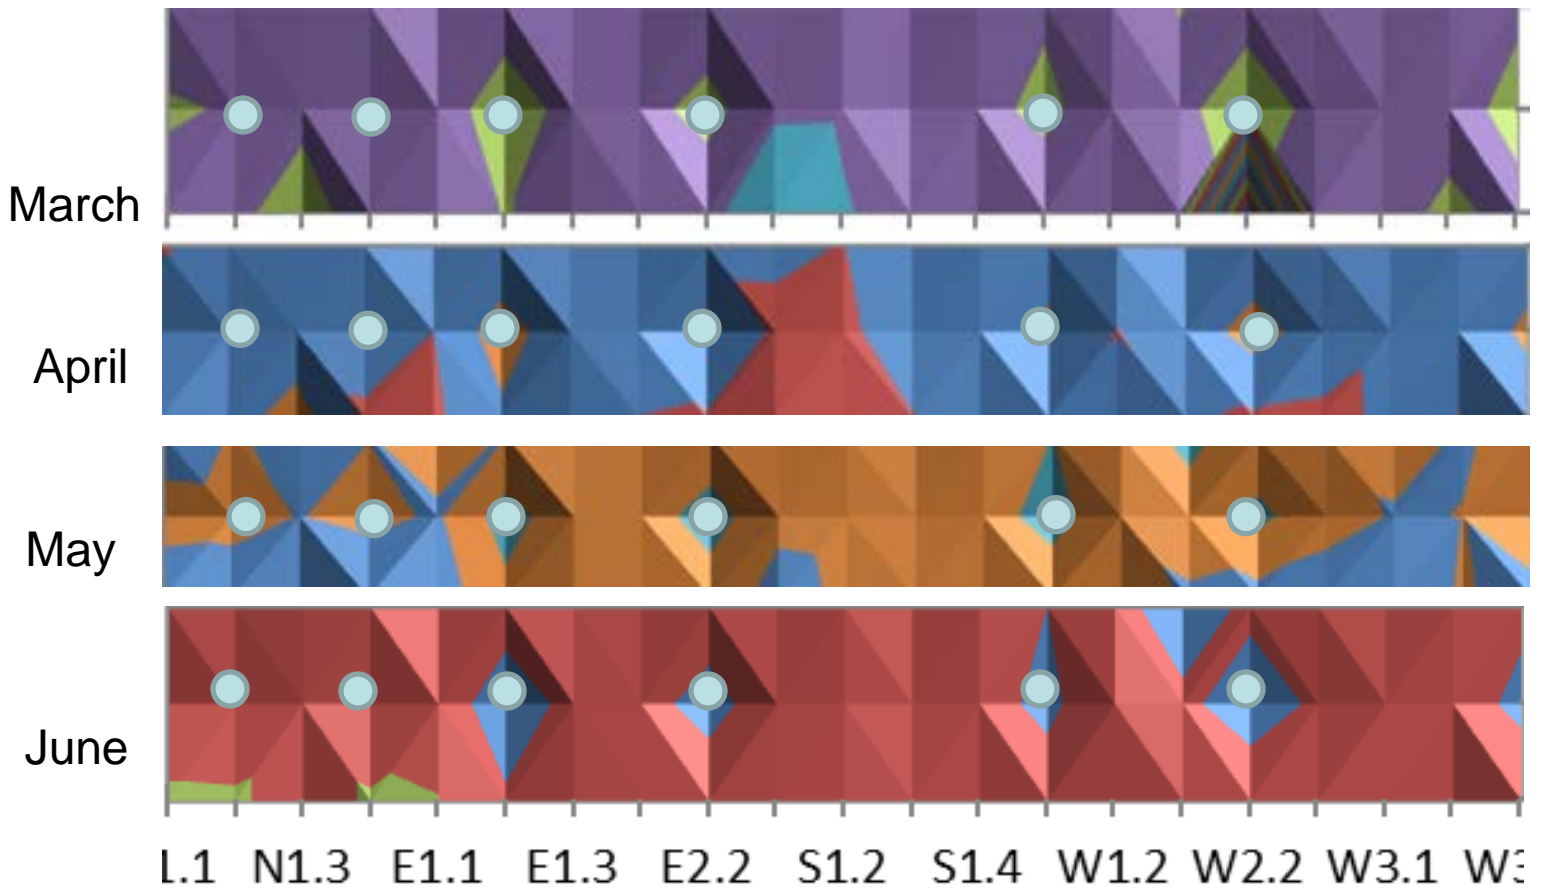
Results - Impact of incandescent lamps to environment (lower RH)

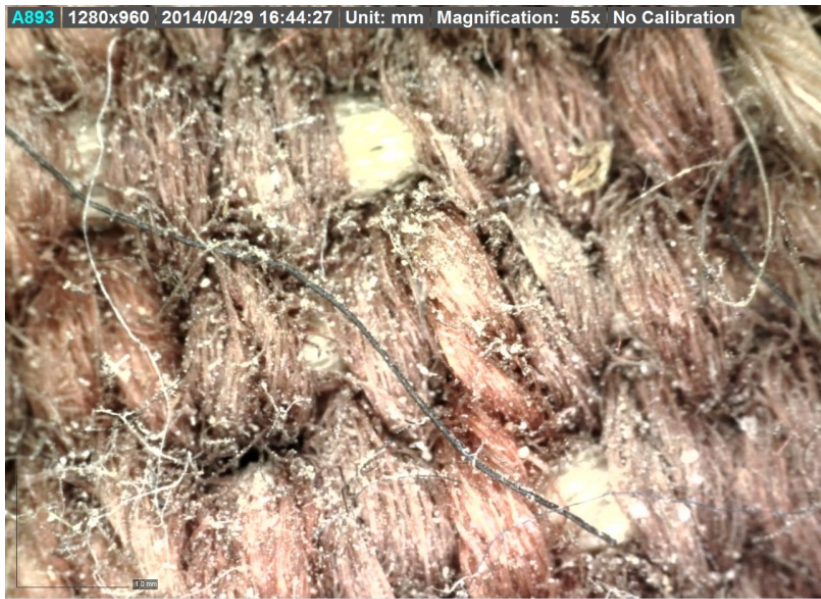
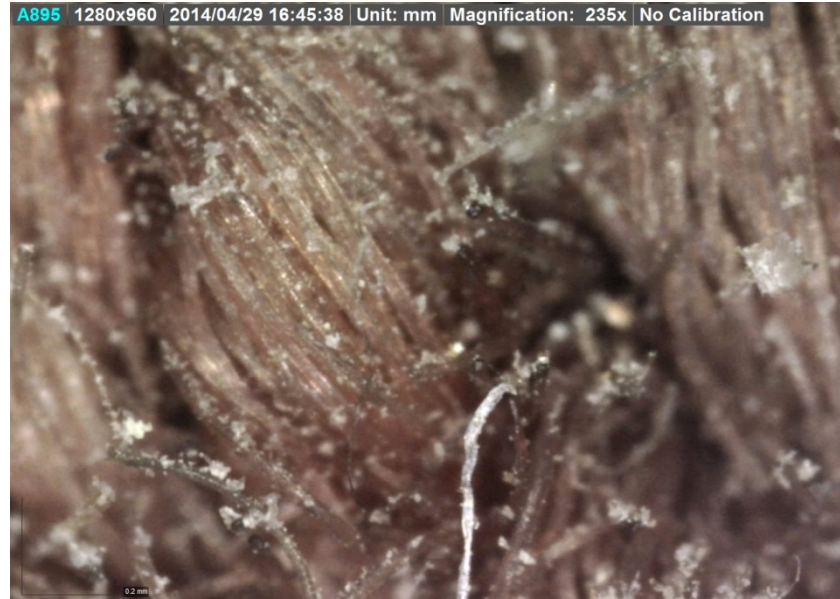
Dust deposition - Wool

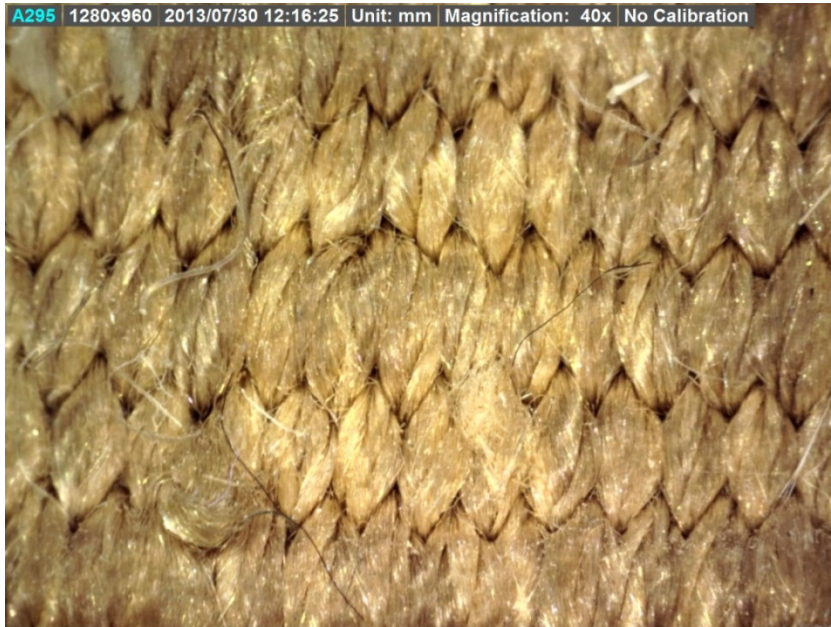
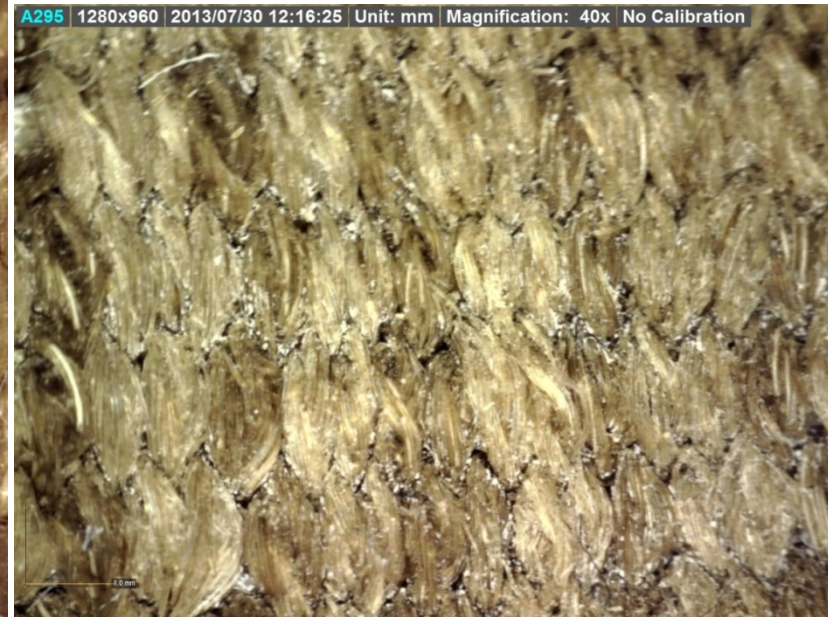
Dust deposition - Silk

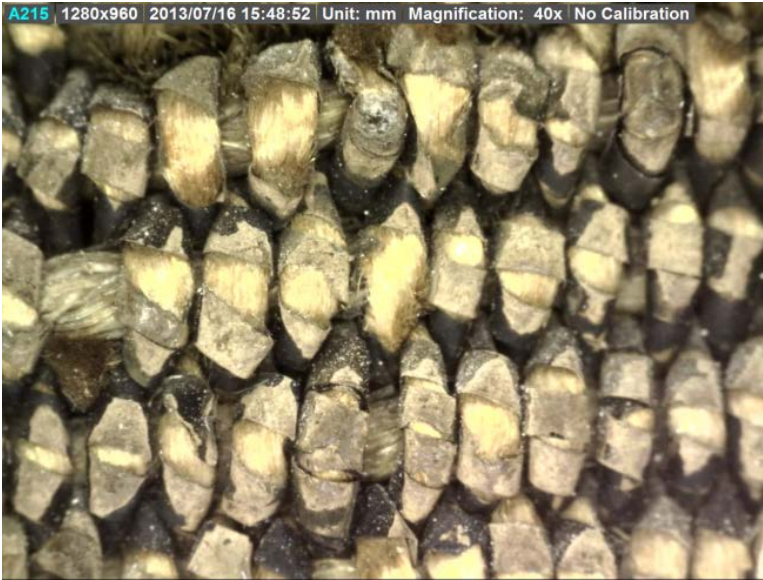
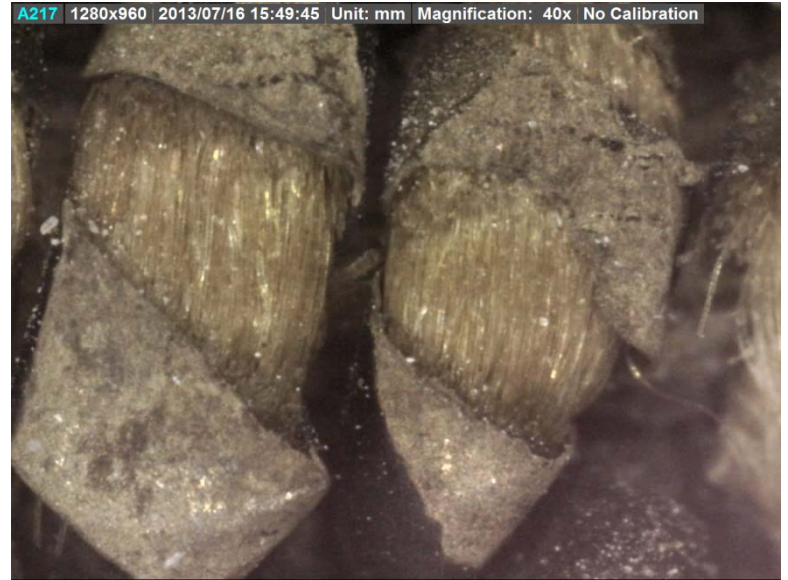
Dust deposition - Metal threads

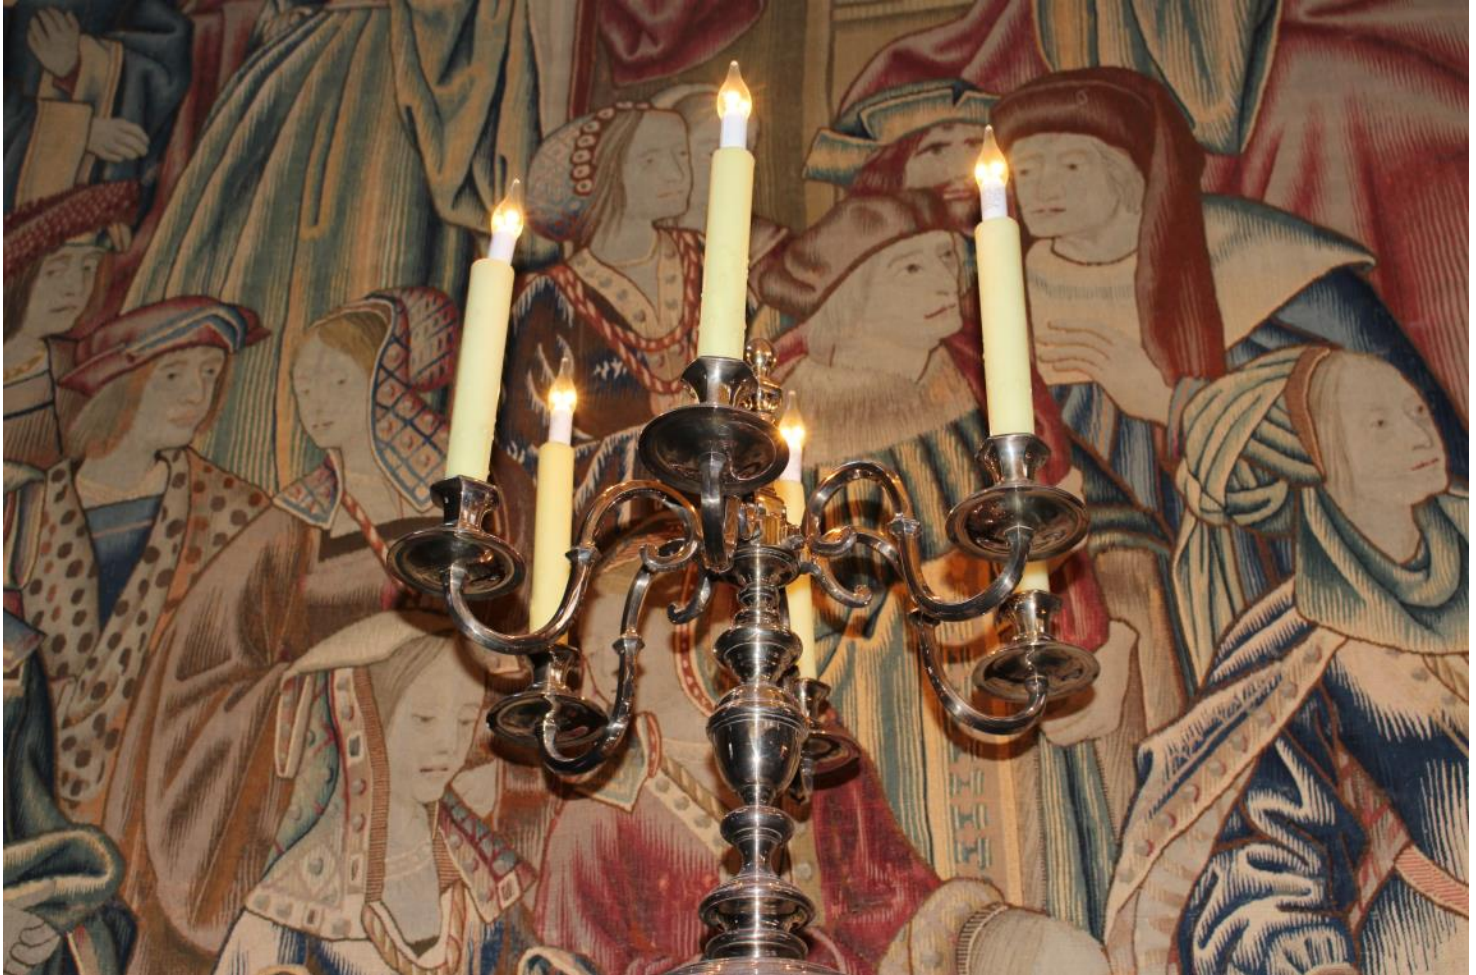
LED lamps on candelabras

**50% saving on light exposure
no heat
energy efficient**

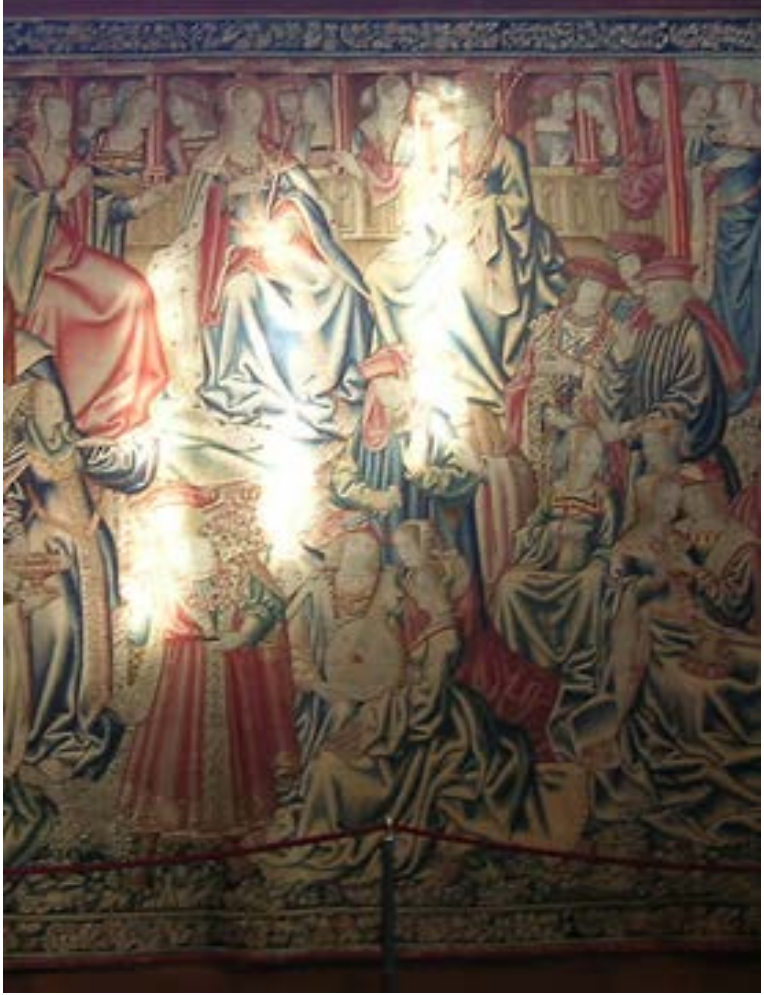
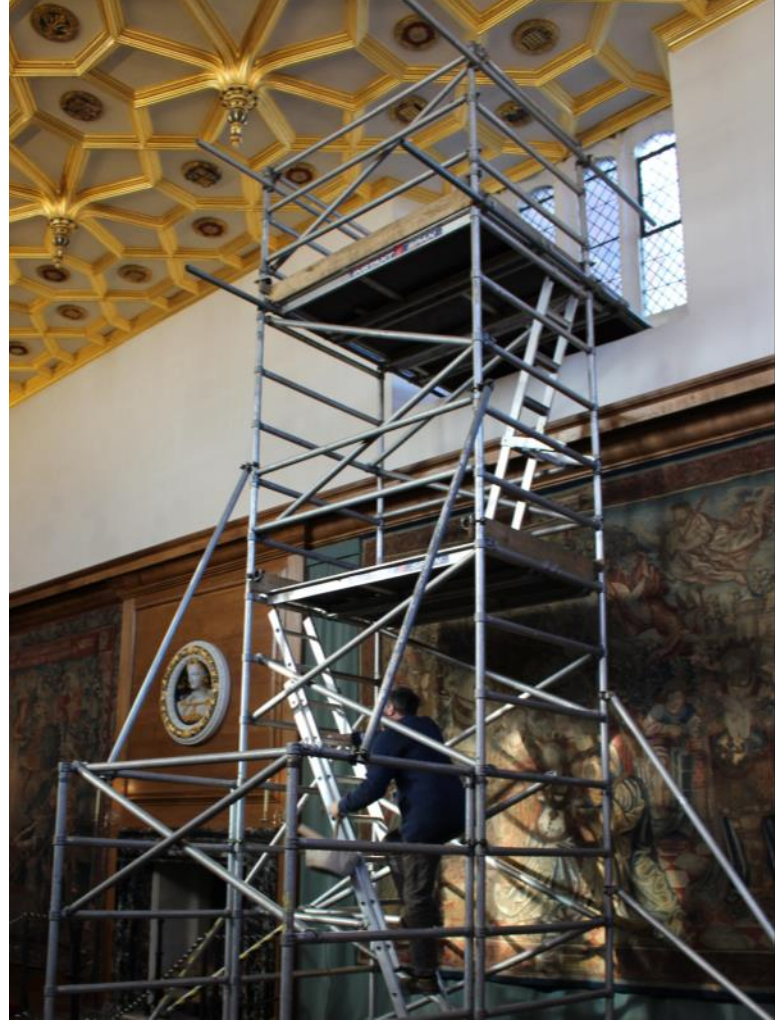
Great Watching Chamber Smart Tint trial February 2015

- Installation of “smart tint” films on the Great Watching Chamber windows
- Design of light protection measures in the Great Hall
- Analysis of tapestries’ microscopic examination data of particulate matter deposition

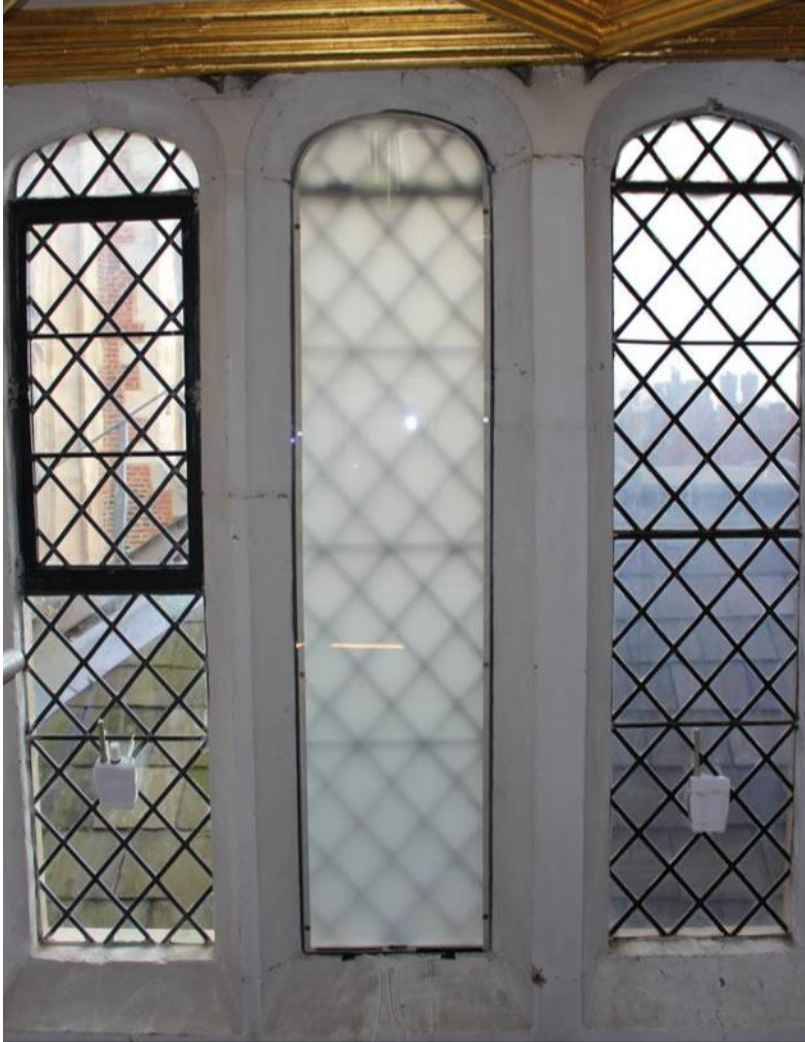
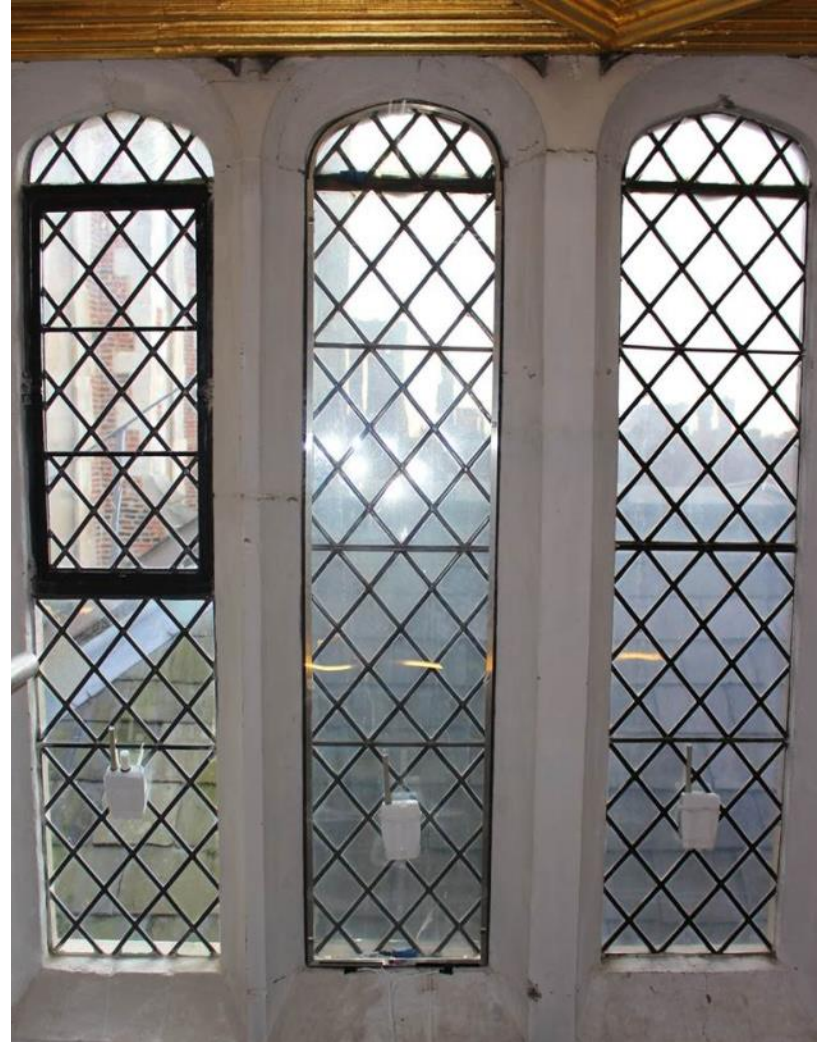
Great Watching Chamber Smart Tint film trial February 2015
